A Fresh Look at Earthquakes and Reservoirs

J.L.HINKS

HR Wallingford Ltd, United Kingdom

This paper seeks to address a wide range of topics which need to be borne in mind when designing or inspecting dams in seismic areas. The title refers to reservoirs rather than dams because there is much to consider other than the seismic behaviour of the dams themselves.

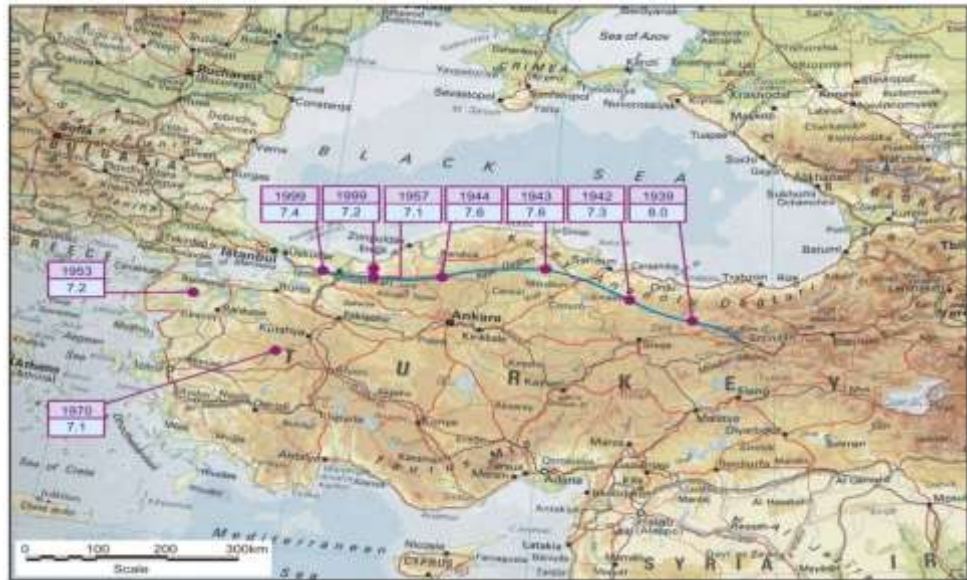
Figure 1. Earthquakes on North Anatolian Fault in Turkey.

Whilst areas most prone to earthquakes are fairly easily identified precise timings and locations of large earthquakes are generally not predictable. A possible exception is the North Anatolian Fault where there were a series of large earthquakes progressing from east to west along the 1,500 km long right-lateral strike-slip fault between 1939 and 1999 (see Figure 1). There are concerns that the next event in the sequence may be close to the city of Istanbul with its population of over 15 million people.

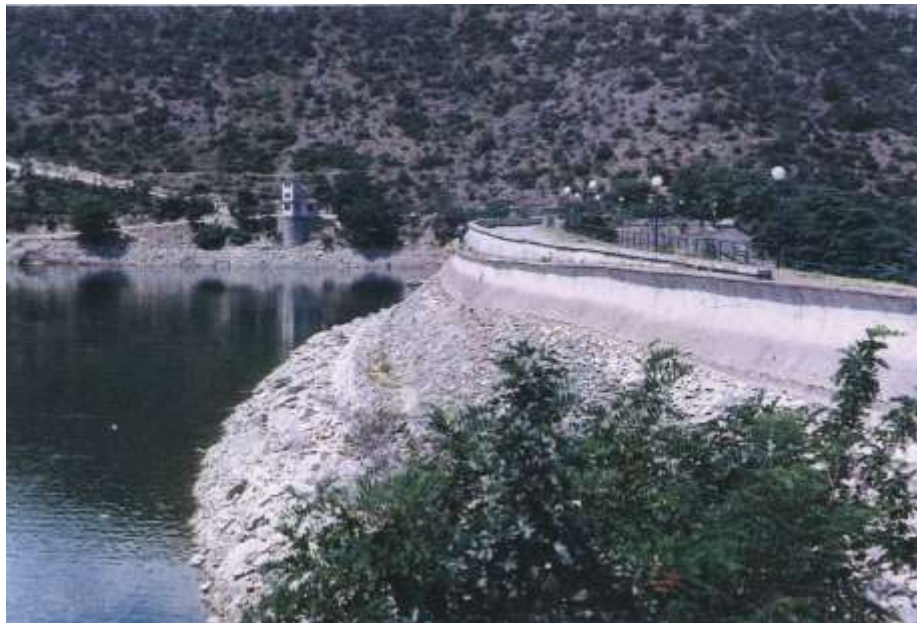
Figure 3. Tikves dumped rockfill dam in North Macedonia.

As one typically has more than 5 m freeboard at well-engineered large dams the conclusion is that settlement in earthquakes is unlikely to threaten the dam. However, there was a period when some rockfill dams were built without compaction. The 113.5 m high **Tikves** dam in North Macedonia, which was built without compaction of the rockfill, has settled by 2.5 m without a nearby earthquake. Further

significant settlement might be expected in a seismic event.

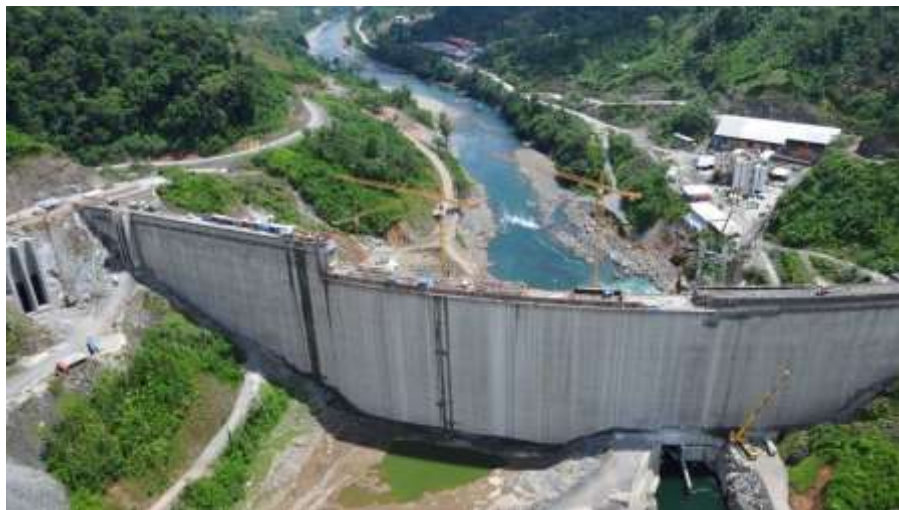
Figure 5. Changuinola Arch-Gravity RCC Dam, Panama (105 m high)

The 105-m high **Changuinola-1** RCC arch-gravity dam in Panama was designed for a PGA of 0.40g^[15]. The dam consists of an arch-gravity section in the middle of the dam with gravity sections on either abutment. The dam was subjected to a reasonably severe earthquake during construction but not since it had been completed and the instrumentation installed.

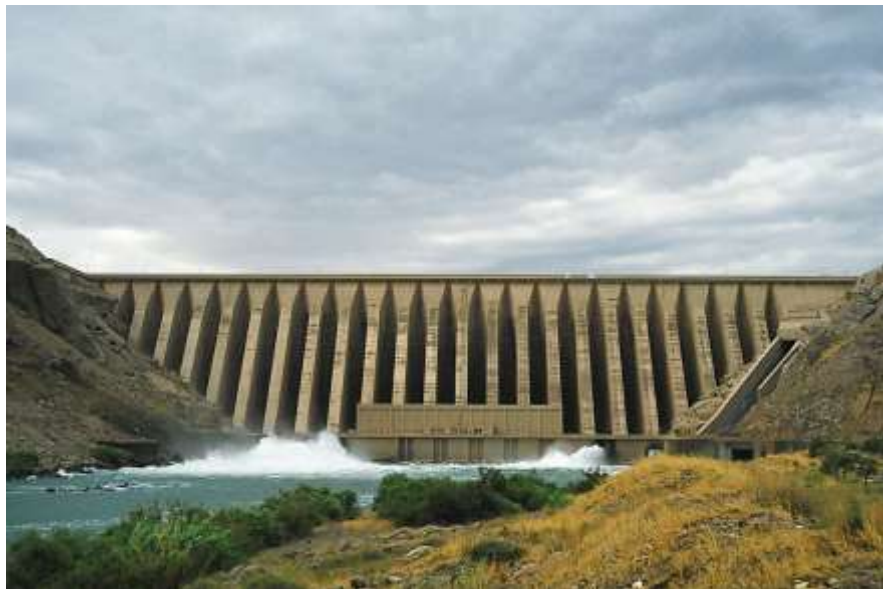
Fig. 6. Sefid Rud buttress dam was damaged near the crest due to ground shaking during the magnitude 7.5 Manjil earthquake of June 20, 1990.

Despite the concerns of analysts about out-of-plane vibrations of the monoliths both of these dams seem to have cracked in response to transverse (upstream/downstream) accelerations.

The Sefid Rud buttress dam in Iran is 106 m high and was affected by the Manjil earthquake of June 1990 which had a magnitude of about 7.5. It has been estimated that the PHGA at the dam would have been about 0.71 g. Major cracks about 10 mm wide developed along horizontal construction joints near to the change of slope on the downstream profile. Unlike at Hsingfengkiang, the level of the cracks varied from monolith to monolith. At monolith 15 there was a 20 mm displacement of the crest of the dam towards the downstream side, with corresponding leakage through the cracks along horizontal lift joints. There was also some relative movement between buttresses.

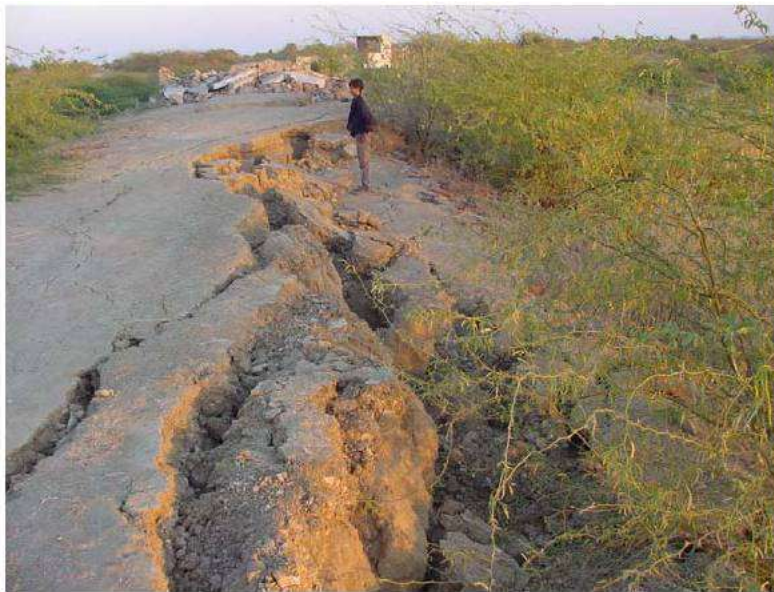
Figure 7. Damage in Bhuj earthquake of 26 January, 2001 (Courtesy Prof S.K.Jain)

There are other dams that could be mentioned including the 245 damaged in the Bhuj earthquake in India on 26 January, 2001. Damage at some of the dams was quite serious although the earthquake fortunately took place when water levels were low.

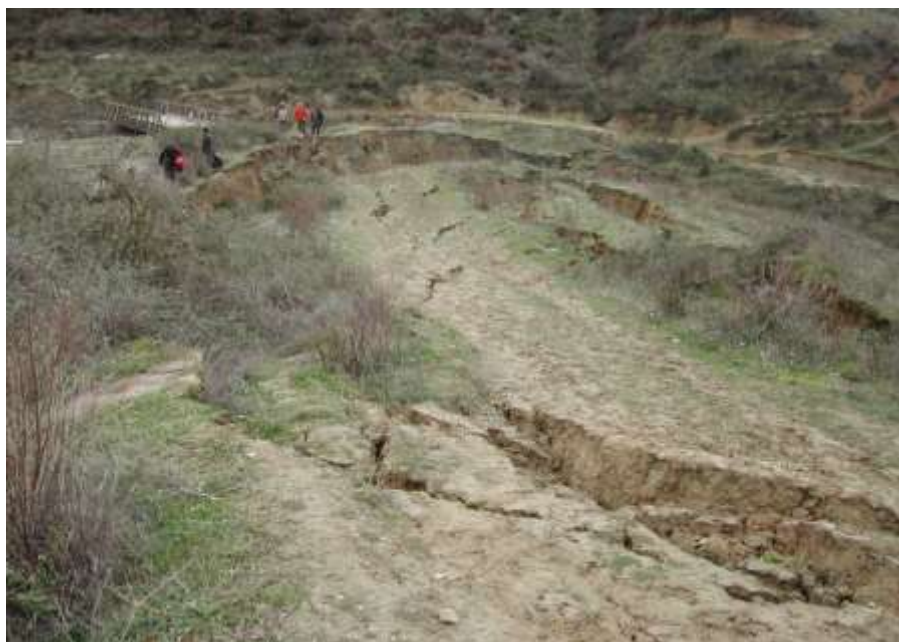
Figure 8. Sharredushk Dam after earthquake of 18 March 2009 (courtesy Tim Hill).

The Sharredushk dam in Albania failed after a modest earthquake on 18 March 2009 (M=4.1) when freeboard was reduced from 1.5 or 2.0 metres to only 0.1 m. The contents of the reservoir were not, however, lost.

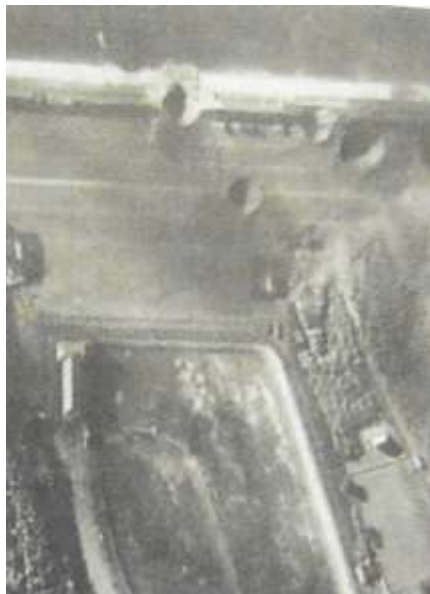
Figure 9. Sorpe dam after heavy bombing in WWII.

In the section on seismic seiches below there is discussion of the repeated overtopping of the Hebgen dam in Montana to a depth of about one metre. This earthfill dam has a concrete corewall as does the Sorpe dam in Germany which withstood heavy bombing in WWII. Statistical evidence suggests that earthfill dams with concrete corewalls are particularly robust (Foster, Fell and Spannagle, 2000)²

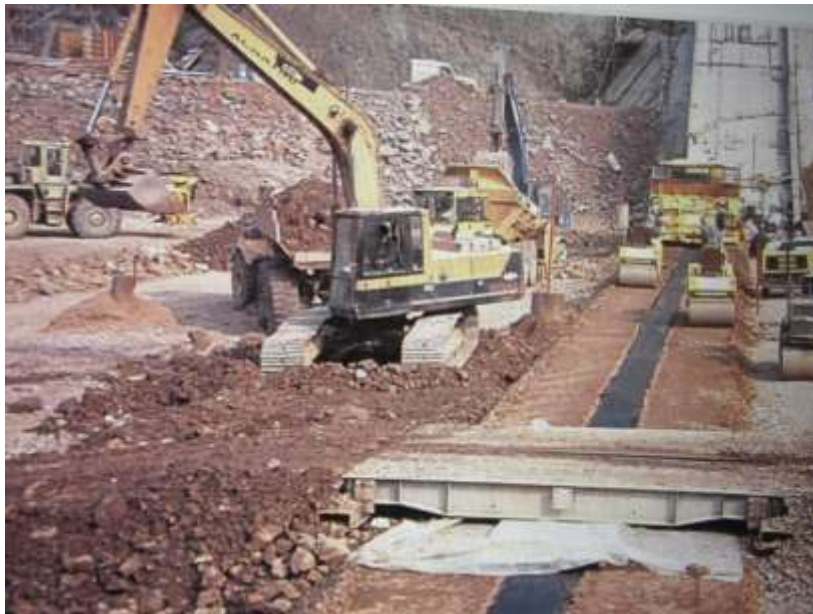
Figure 10. Simultaneous compaction of asphaltic core and filters (Høeg, 1993)

During an extreme earthquake, it has been suggested that the induced permanent shear displacements for an embankment dam may become so large that a narrow core is sheared off and a gap opens. For such an eventuality it would be advisable to have a relatively fine-grained material next to the asphaltic concrete core. It is essential that the downstream shell and toe is designed with adequate drainage capacity to handle accidental leakage and prevent dam failure even if the temporary water loss is dramatic. (quoted by Høeg, 1993)¹⁹.

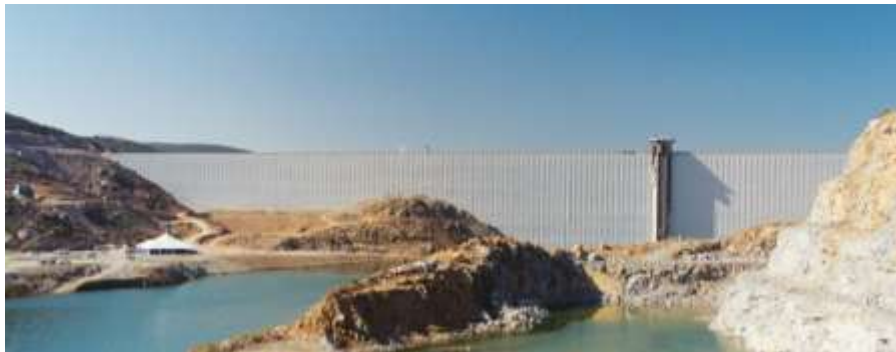
Figure 11. Exposed PVC geomembrane at Olivenhain Dam (courtesy Carpi Tech)

The dam was required to remain watertight even in case of a seismic event. An external geomembrane liner against formed RCC, and a reinforced conventional concrete face cast-in-place after RCC placement, received the highest score among the 16 possible alternatives. The geomembrane liner alternative was selected due to a less adverse impact on overall construction schedule and technical merit considerations (Kline et al., 2002)²⁰. The exposed upstream geomembrane system was installed in 2003.

With the reservoir about 50% full, a magnitude 5.2 earthquake hit the San Diego region in June 2004, centered about 60 km from the dam. Significant shaking was reported, and a peak horizontal acceleration of 0.18g recorded. No damage to the dam was observed and seepage did not increase following the event. The reservoir filling was completed in January 2005. The geomembrane system continues to exceed performance specification for seepage.

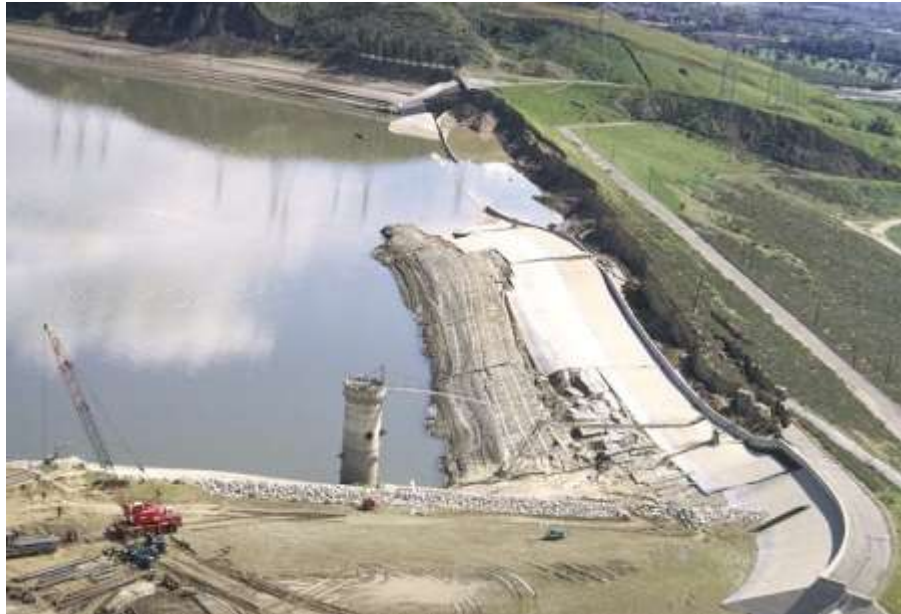
Figure 12. Lower San Fernando dam after earthquake of 9 February, 1971. (Source: Earthquake Engineering Research Center, University of California, Berkeley)

As noted in the section on Hydraulic Fill the upstream slope of the 38 m high Lower San Fernando Dam in California failed due to liquefaction during the 1971 San Fernando earthquake. The collapse occurred shortly after earthquake shaking ended and was attributed to loss of strength in the hydraulic fill due to liquefaction.

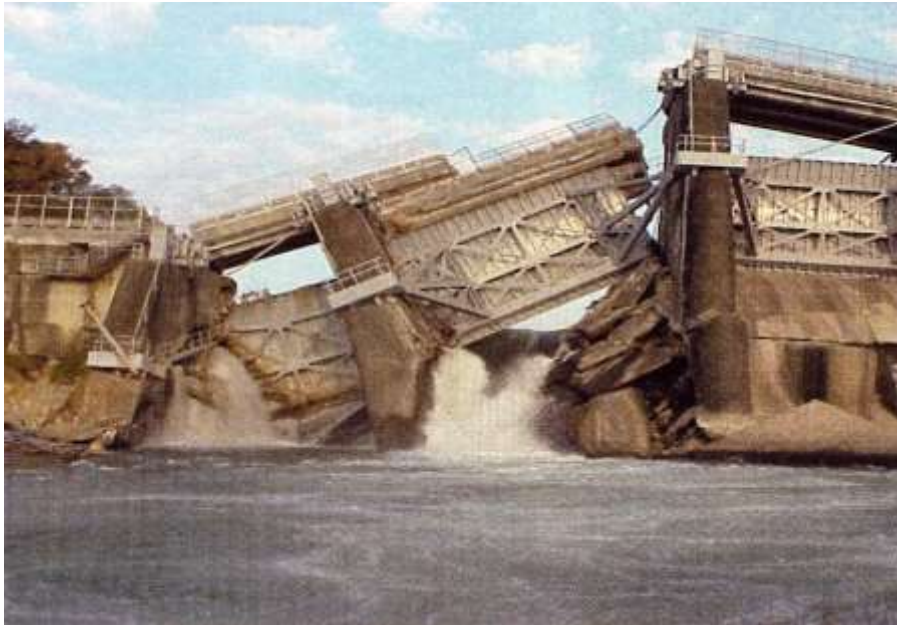
Figure 13. Shih-Kang dam after the earthquake of 21 September 1999.

movements on an active fault beneath a dam can destroy the structure (Hansen and Nuss, 2011)³.

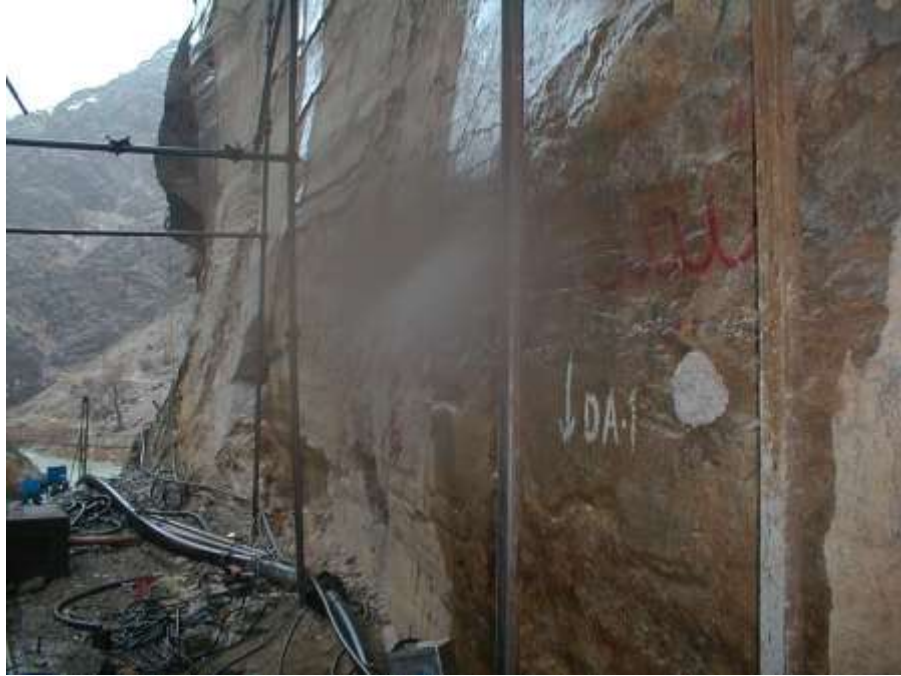
Figure 14. Secondary fault at left abutment of Rudbar-Lorestan dam in Iran

It was felt possible to design the dam for shaking as a result of an earthquake on the main fault but there were concerns about possible movements along secondary faults, and other discontinuities, in the footprint of the dam. One of the secondary faults, at the left abutment, is shown in Figure 14. The investigation of this fault

showed that it had experienced maximum horizontal displacement of up to 1.4 m in a single event. Based on additional seismotectonic studies and interpretation it was decided that a clay core rockfill dam with wide filter zones was to be preferred.

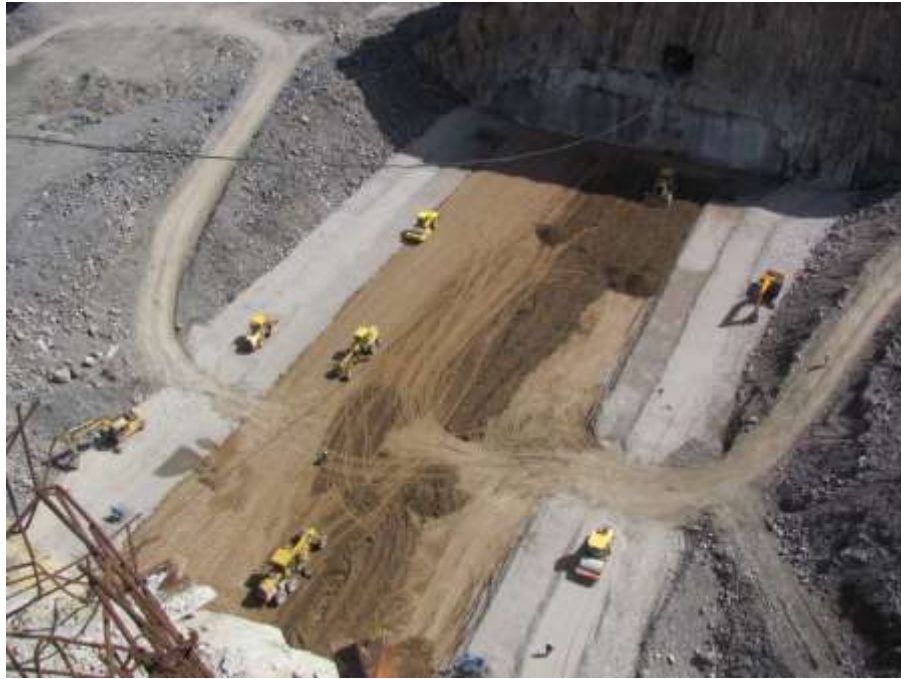
Figure 15. Rudbar-Lorestan Dam under construction.(courtesy Martin Wieland)

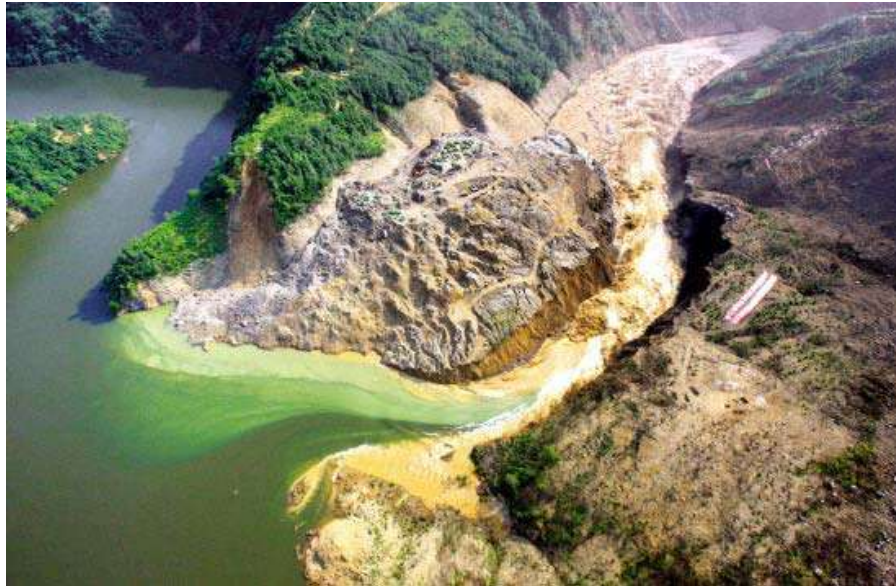
Figure 16. Tangjiashan landslide dam (Photo by Mr. Li Gang)

There was no road access after the earthquake so initial information came from satellite photography. Access by helicopter was first obtained eight days after the earthquake. A channel had to be constructed to release the water which was flowing into the reservoir at a maximum rate of 170m³/s. As this lake threatened more than a million people downstream of the landslide dam, it was decided to bring in equipment using a large Russian helicopter with a lifting capacity of 13 tonnes. In this way 24 excavators were lifted in, 13 bulldozers and 8 tipper trucks. The necessary work was done in 10 days.

Good geological records were used to predict that the relief channel would only scour down to a certain level. In fact flows reached 6,500 m³/s which was slightly more than the flood with a return period of 200 years.

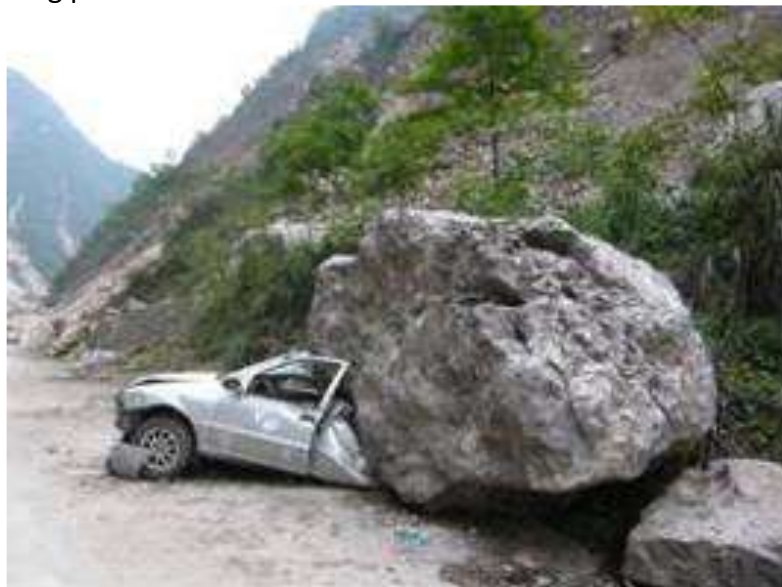
Figure 17. Typical rockfall during Wenchuan earthquake in China on 12 May, 2008.

A major feature of the magnitude 7.9 Wenchuan earthquake of 12 May, 2008 was the rockfalls which obliterated many kilometres of main roads, damaged power plants and destroyed transmission lines. The rockfalls would have made access to many dams impossible for long periods of time.
